FINAL REPORT

Mitchell River Silt Jetties Shoreline Protection and Enhancement Project

Parks Victoria

March 2015

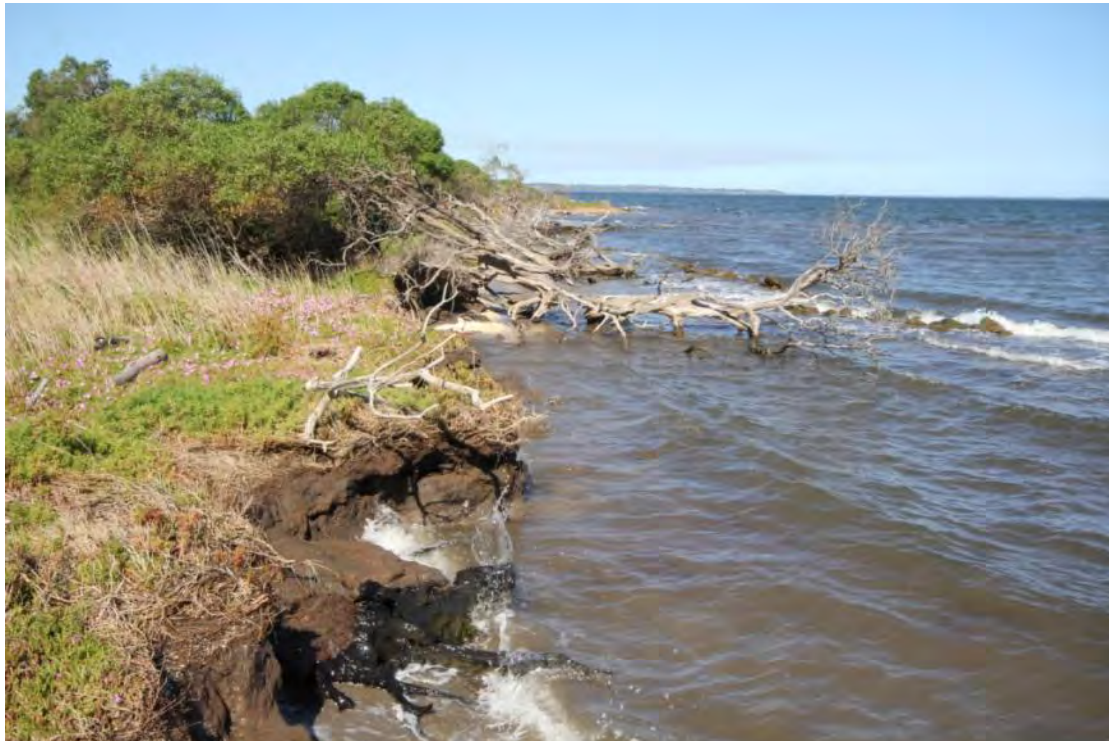
Plate 1: An eroding shoreline on the Lake King side of the southern silt jetty. Note the vertical shoreline and easily erodible silty material. The breaking waves to the right of the image mark the position of rock beaching previously placed to prevent erosion.

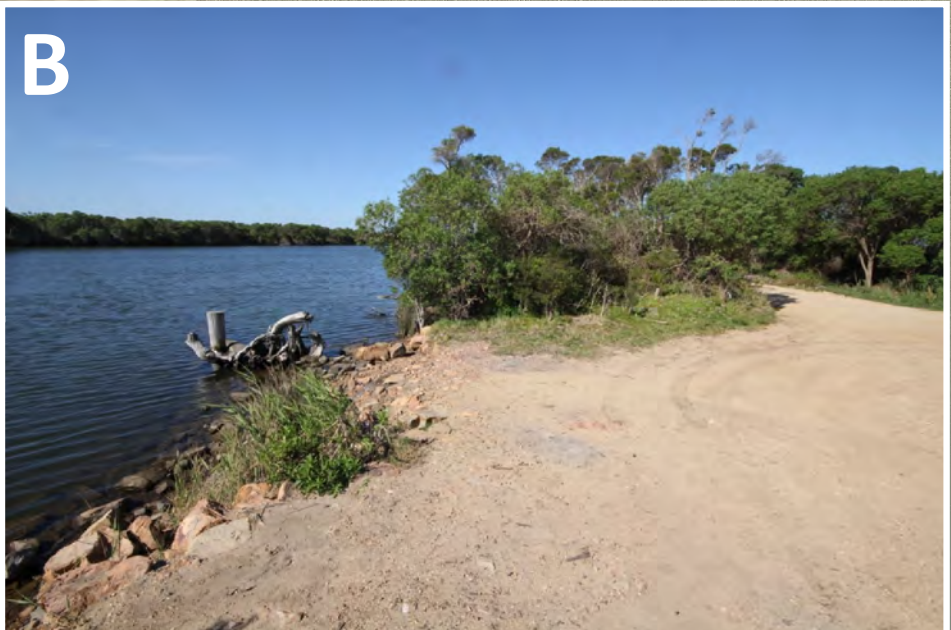
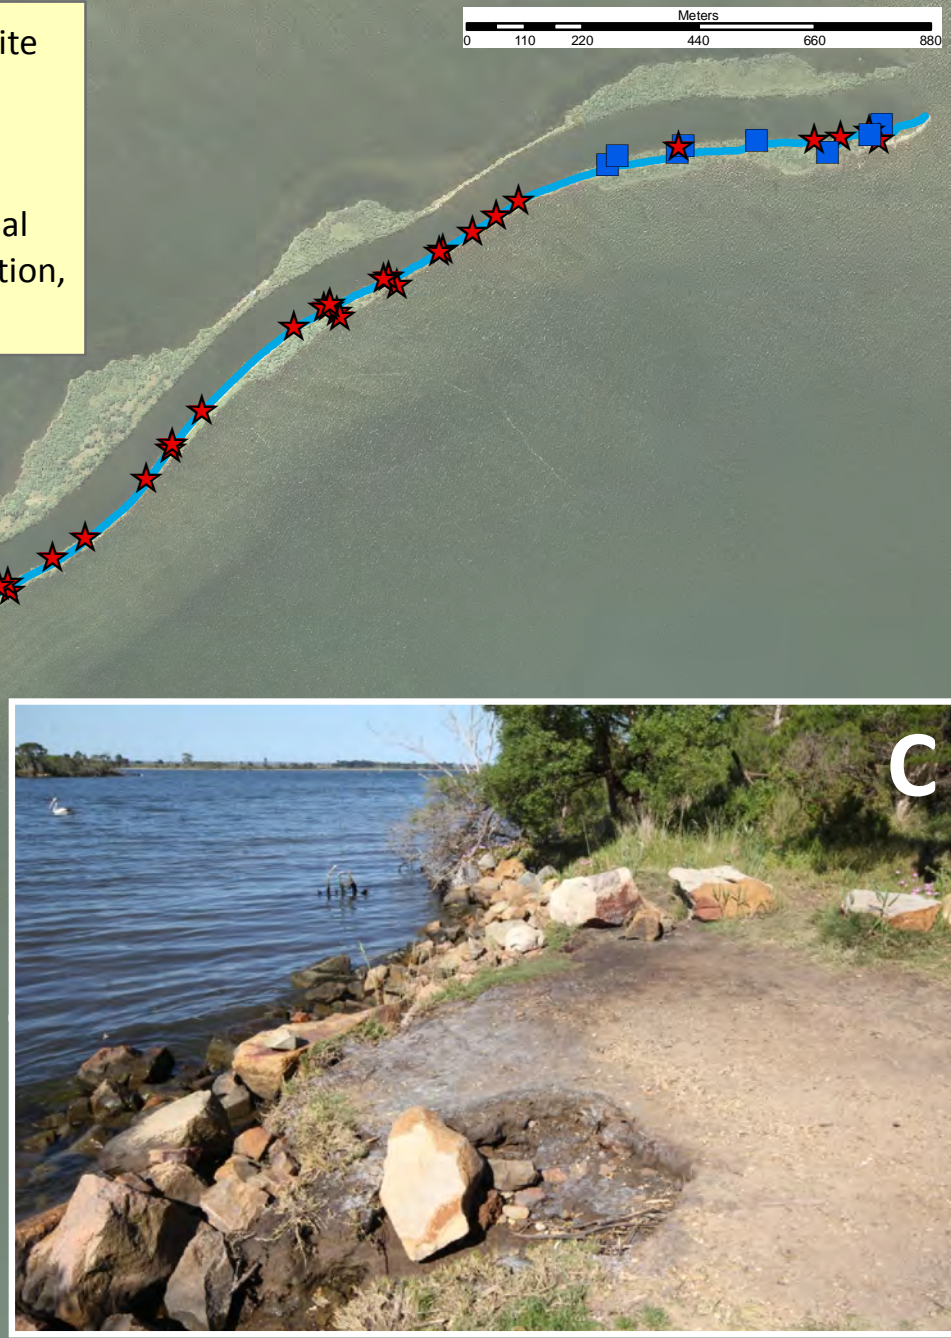
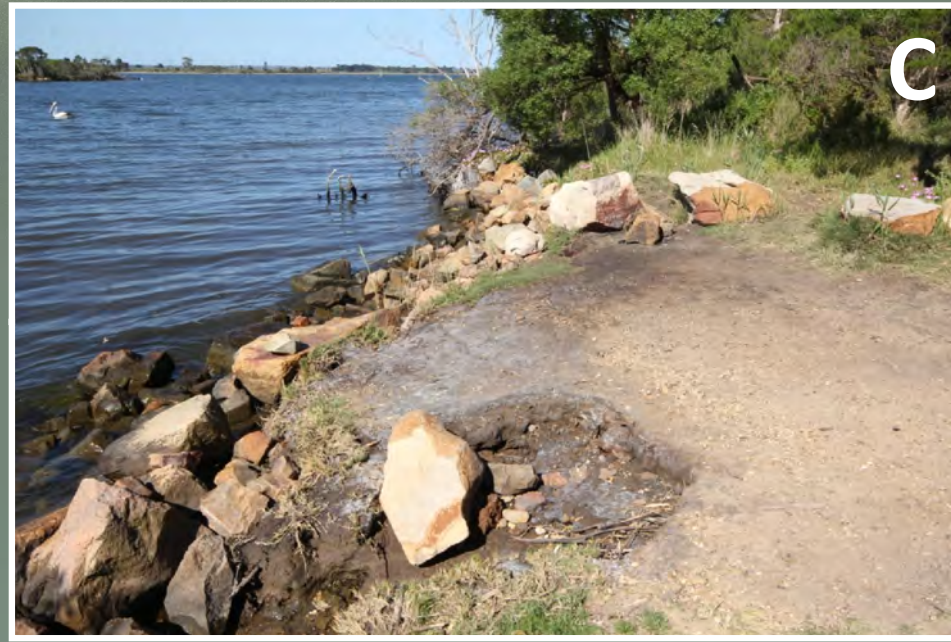
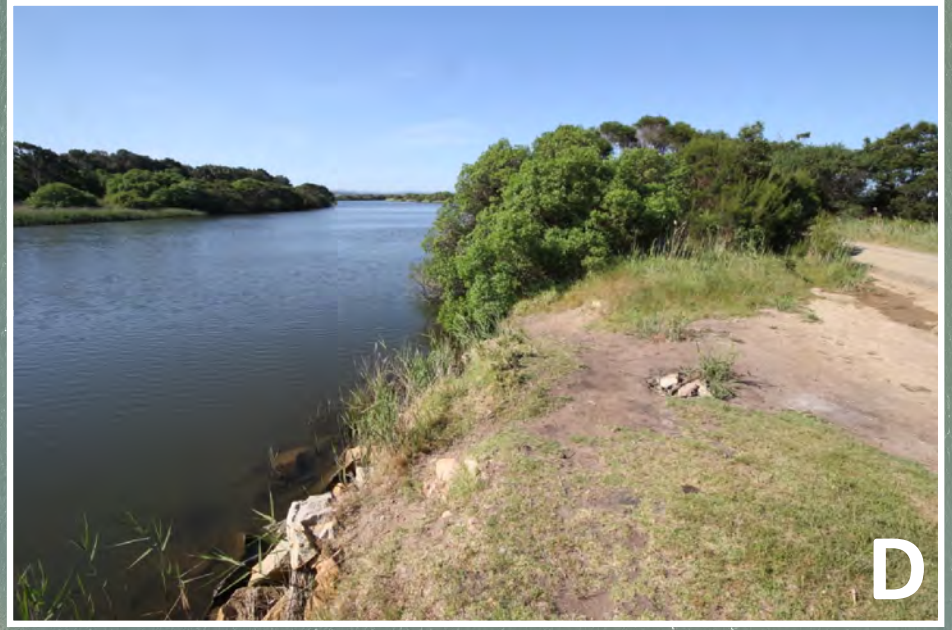
A - An example of the data collected in the site disturbance assessment, mapping areas of vegetation loss and compaction.

B, C and D - Examples of areas where informal access points have resulted in loss of vegetation, compaction of the soil, and poor drainage

Site visits were undertaken along the length of the southern silt jetty, with areas of disturbance noted and mapped. Spatial information was recorded using a GPS unit and ESRI ArcPad software.

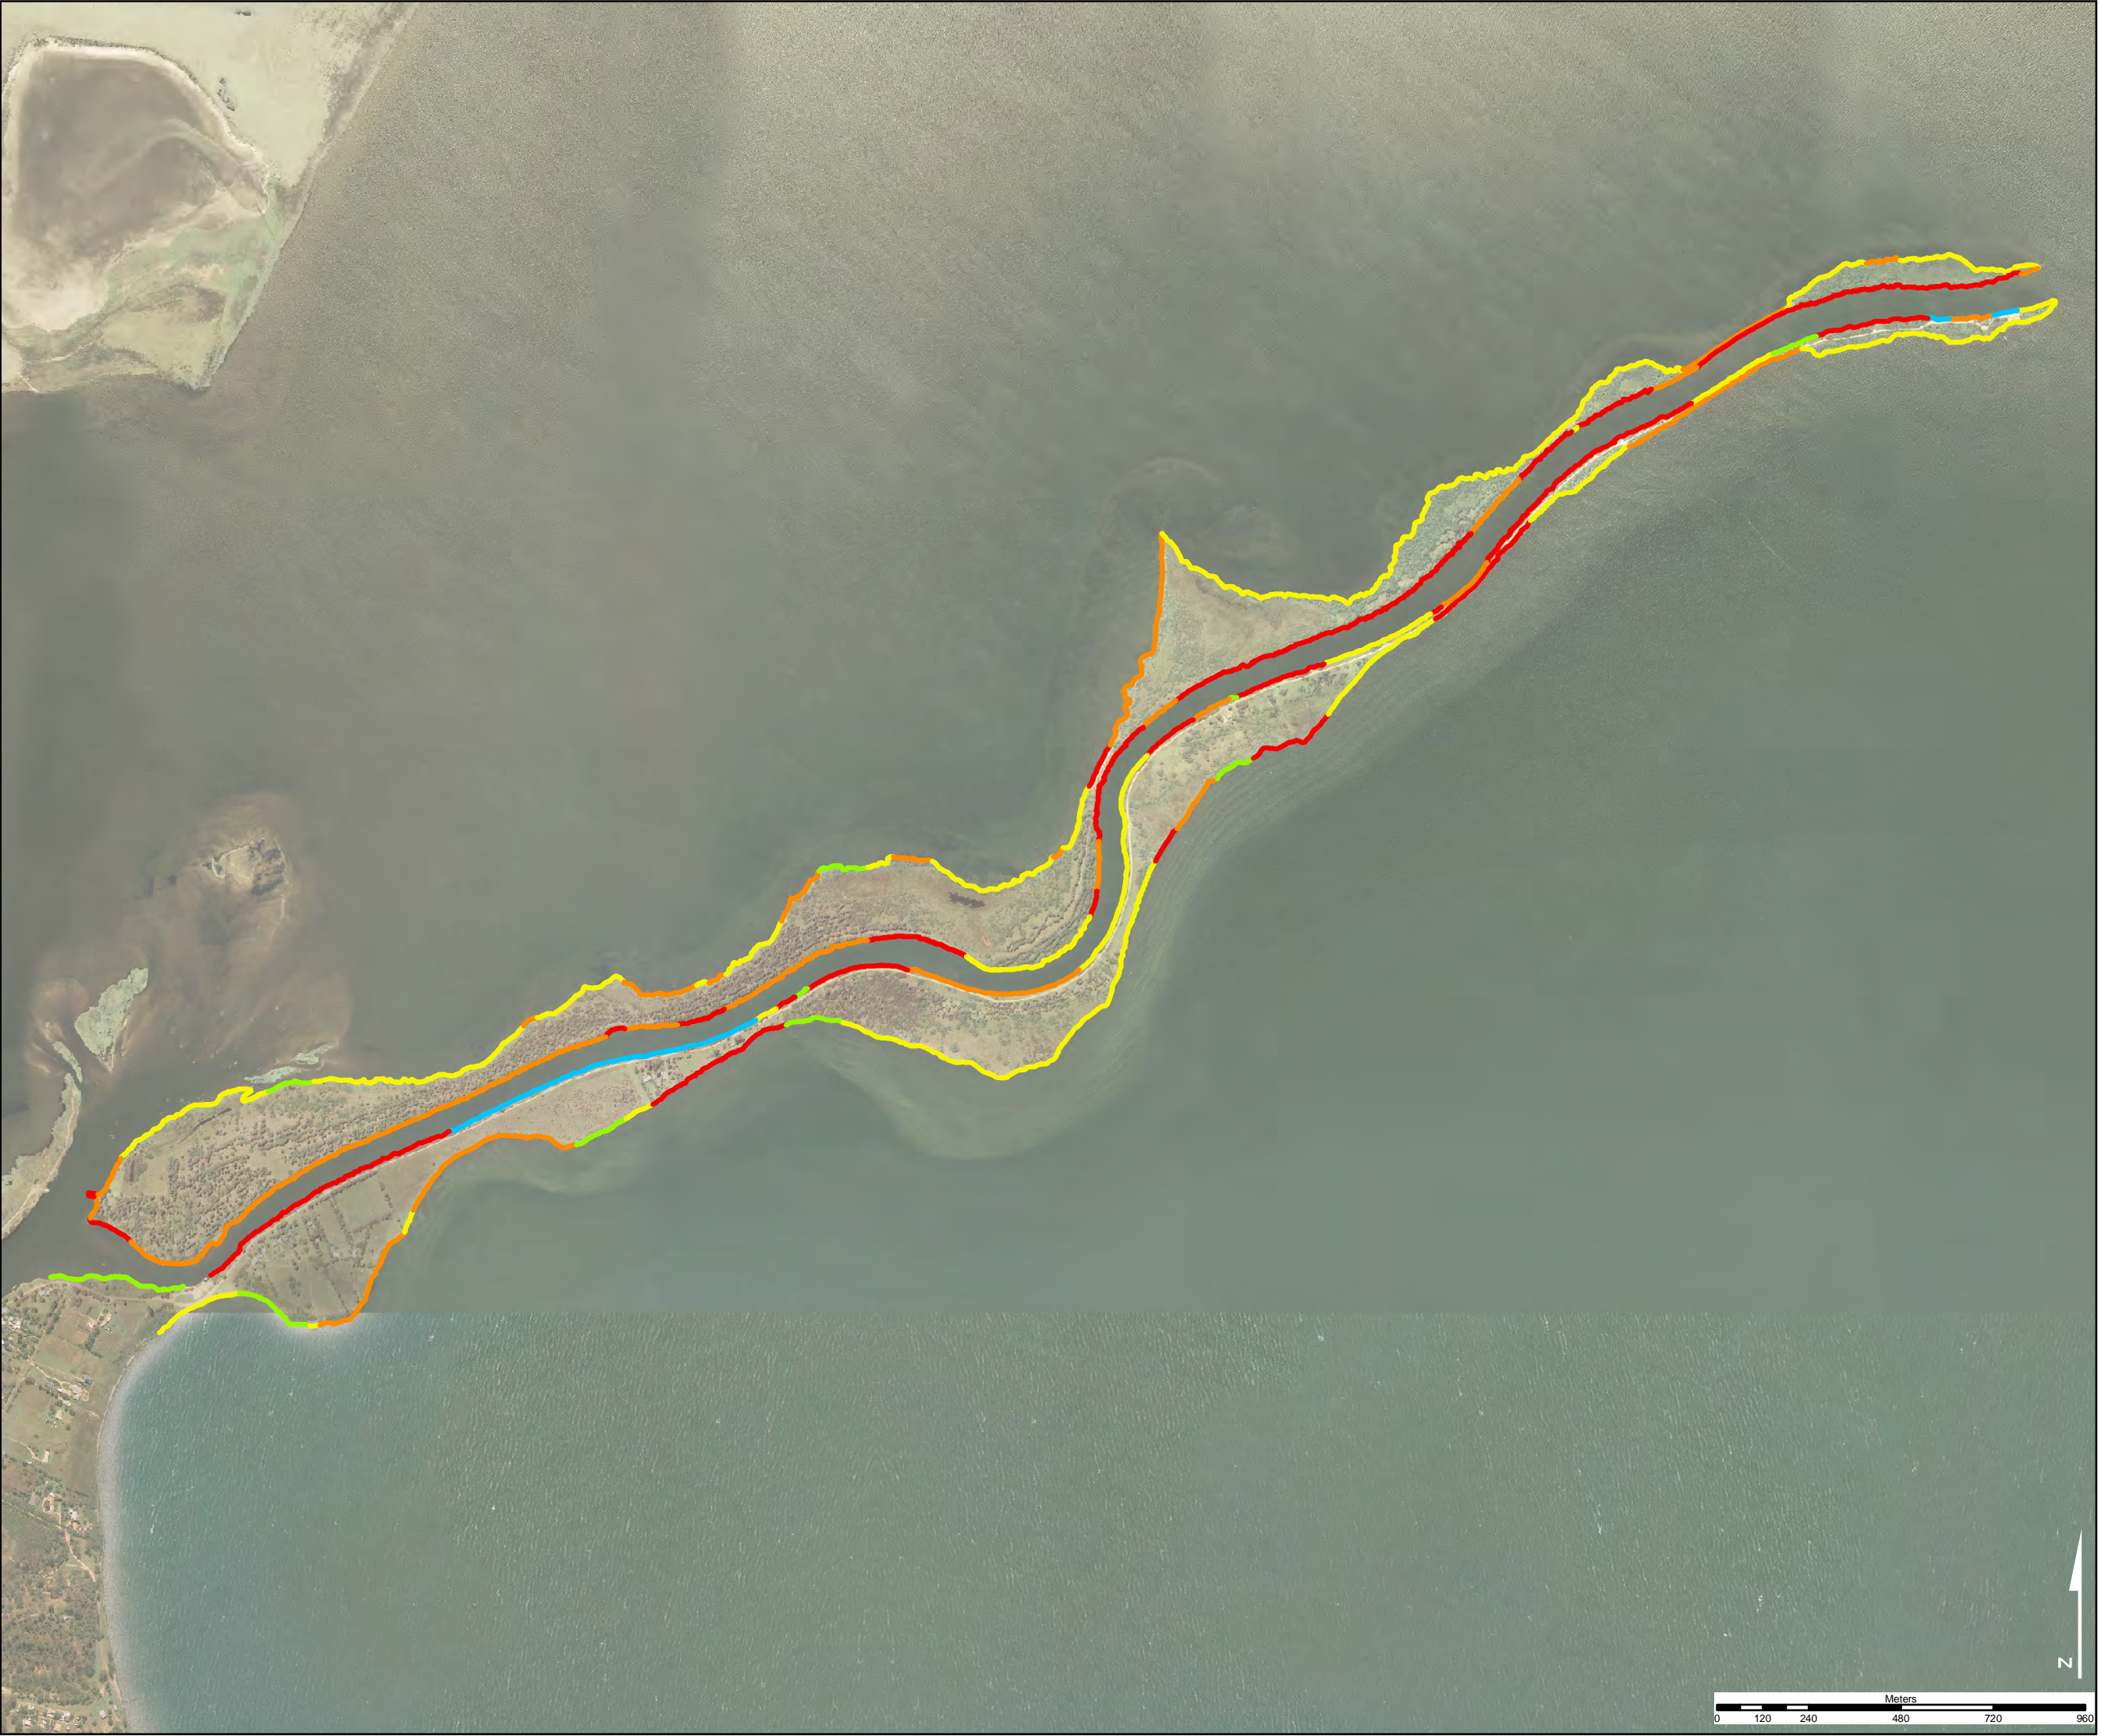
Resistance Rating

- Very Low
- Low
- Moderate
- High
- Very High

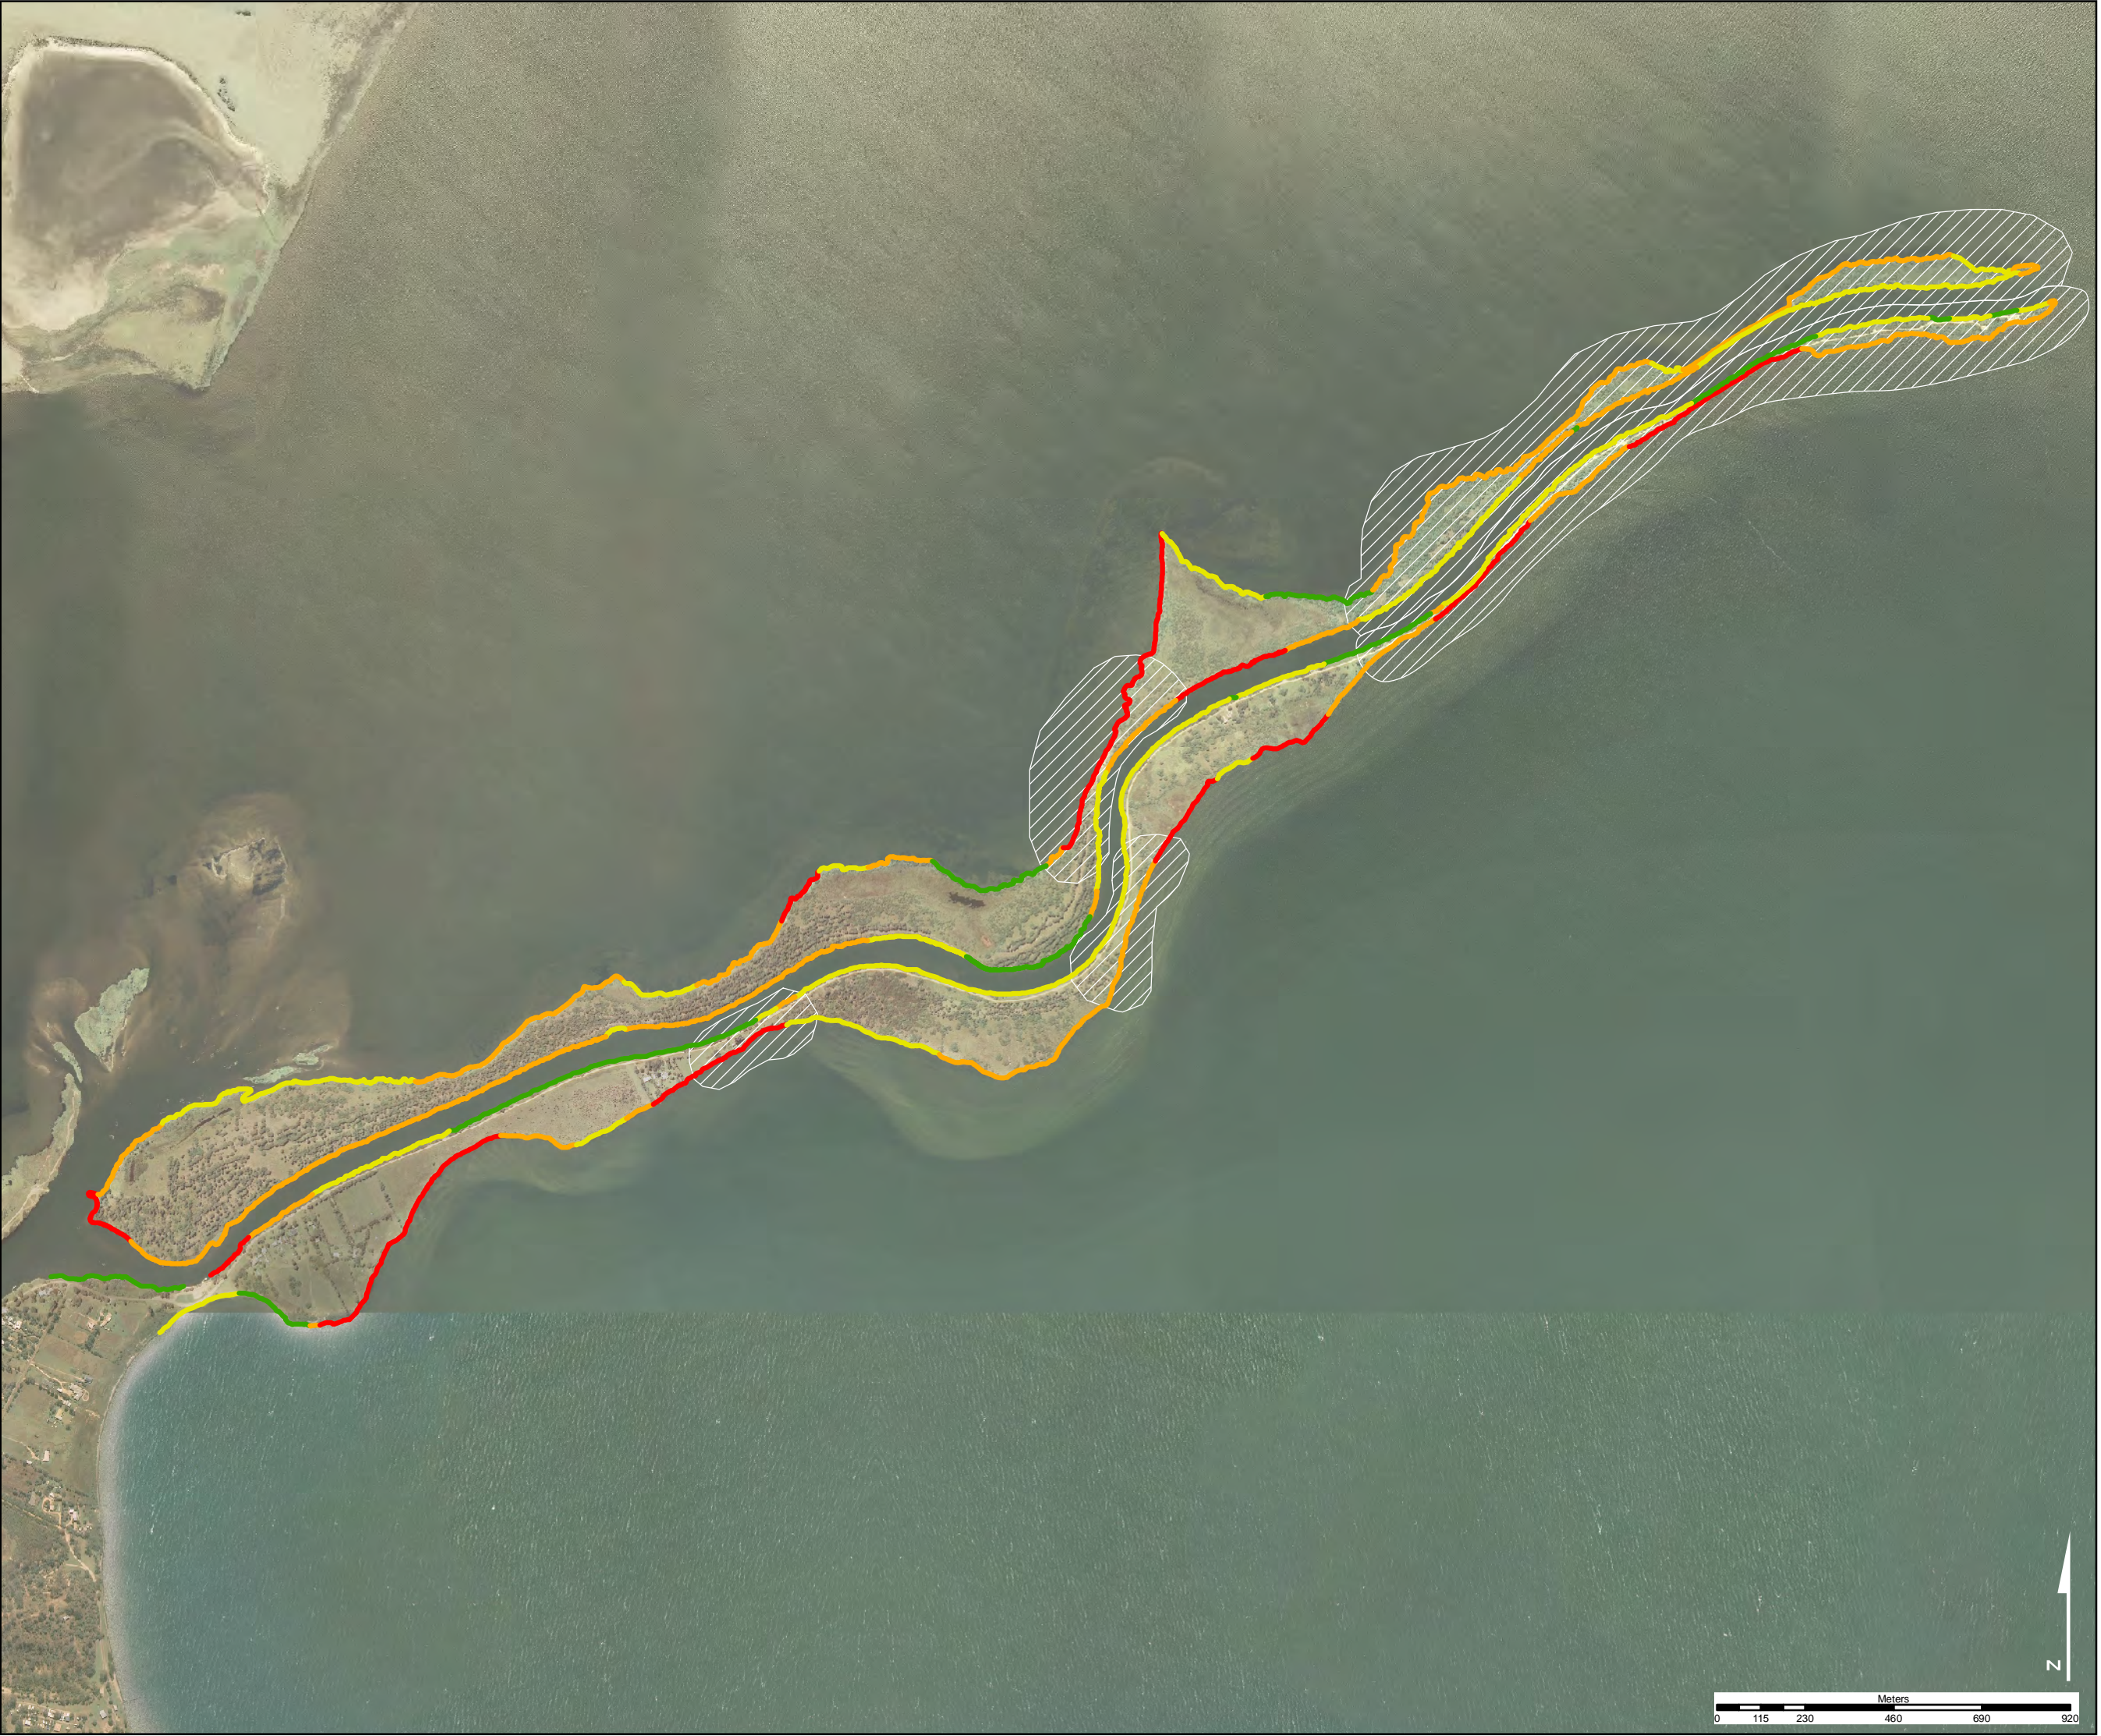
Areas of High
Erosion Risk

When determining the areas of greatest erosion likelihood across the Mitchell River Silt Jetties, an assessment has been made that combines the two factors that determine the susceptibility of a given area to erosion:

- Low
- Moderate
- High
- Very High

Figure 2. Erosion risk: This map shows areas identified as being at the greatest erosion risk across the site, using a combination of the information collected from the technical investigations. In essence, $\text{Erosion Risk} = \text{Excess energy} \times \text{Level of resistance}$

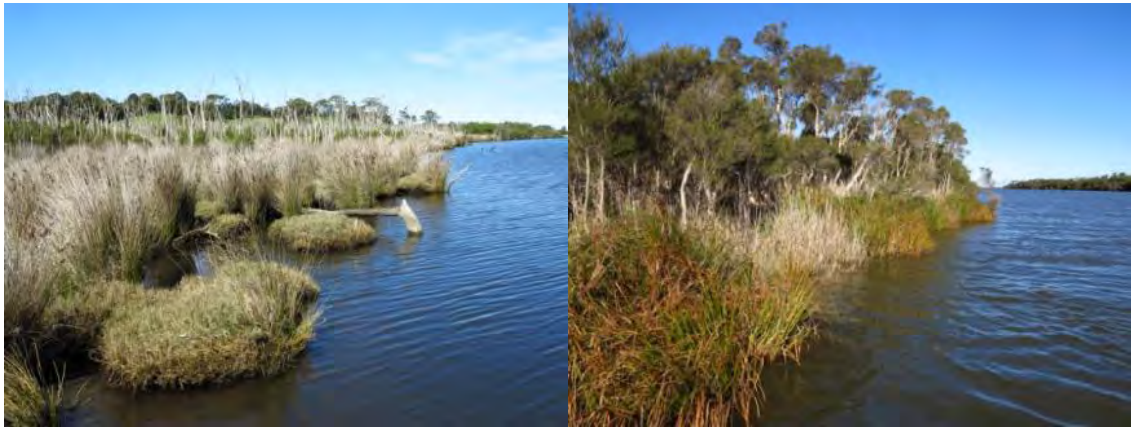
Plate 2: left (a) shows Sea Rush growing along the lower Nicholson River; right (b) shows Leafy Twig-rush growing along the lower Avon River. (Paul Boon, September 2014).

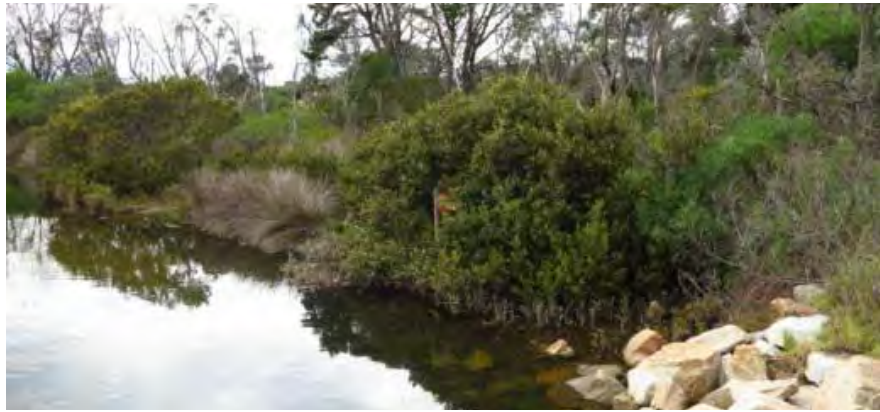
Plate 4: Small stand of mangroves at the distal end of Cunninghame Arm. (Paul Boon, September 2014).

Since the late 1980s or early 1990s, however, a small stand of mangroves has established in the distal end of Cunninghame Arm and, more recently, isolated specimens have been observed near Bullock Island at Lakes Entrance (Plate 4). It is very likely that mangroves have appeared in the saltier parts of the Gippsland Lakes in response to the increasing salinization of the water bodies (Boon *et al.* in press). The area around Jones Bay to the north and Lake King are likely to be too fresh to support a stand of mangroves and it is unclear whether they could establish successfully in such an erosive environment. Nevertheless, with the ongoing salinization of the Lakes, there may be, in the future, isolated, small sheltered areas along the outer margins of the silt jetties that could prove suitable for mangrove establishment. It is, however, unclear to what extent the establishment of mangroves in these areas would meet with public or agency approval.

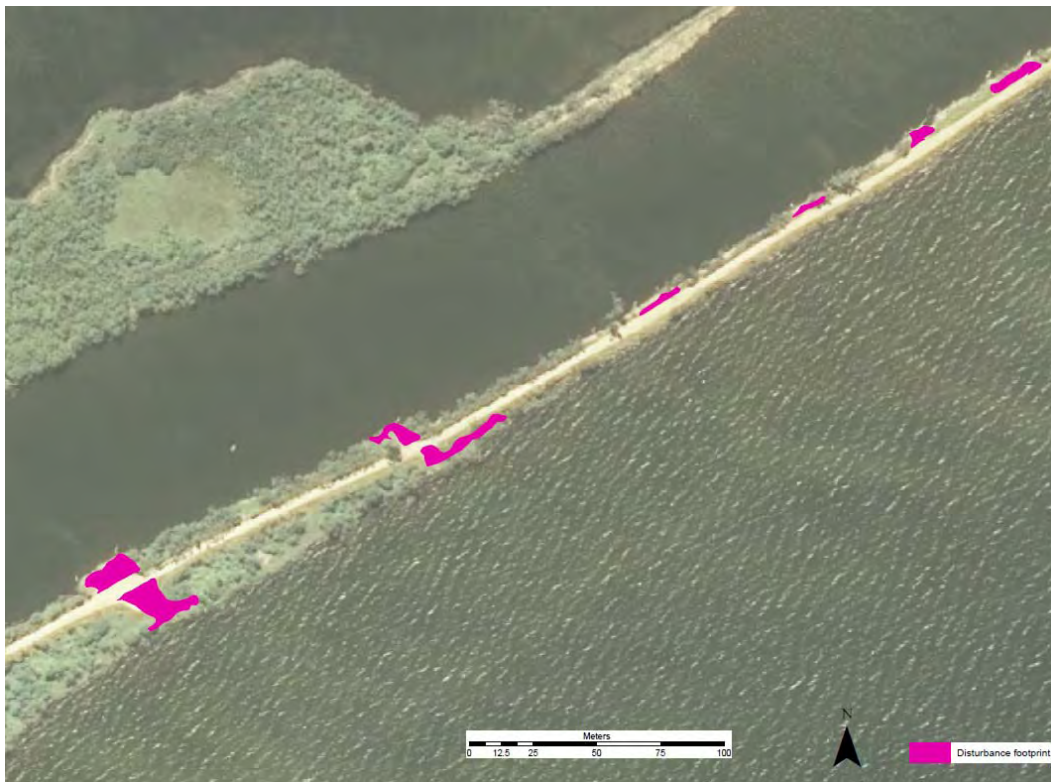
Figure 1. Site Disturbance Assessment: site visits were undertaken along the length of the silt jetties to note and map areas of disturbance. Assessments were made of road and track location, road drainage, river and lake access points. This assessment noted 57 areas of disturbance (46 informal, 11 formal), with over 4000m² of vegetation impacted or removed at informal access points. Issues relating to this disturbance include drainage at informal access points, drainage from the road, and inability for vegetation to establish dues to spatial constraints.

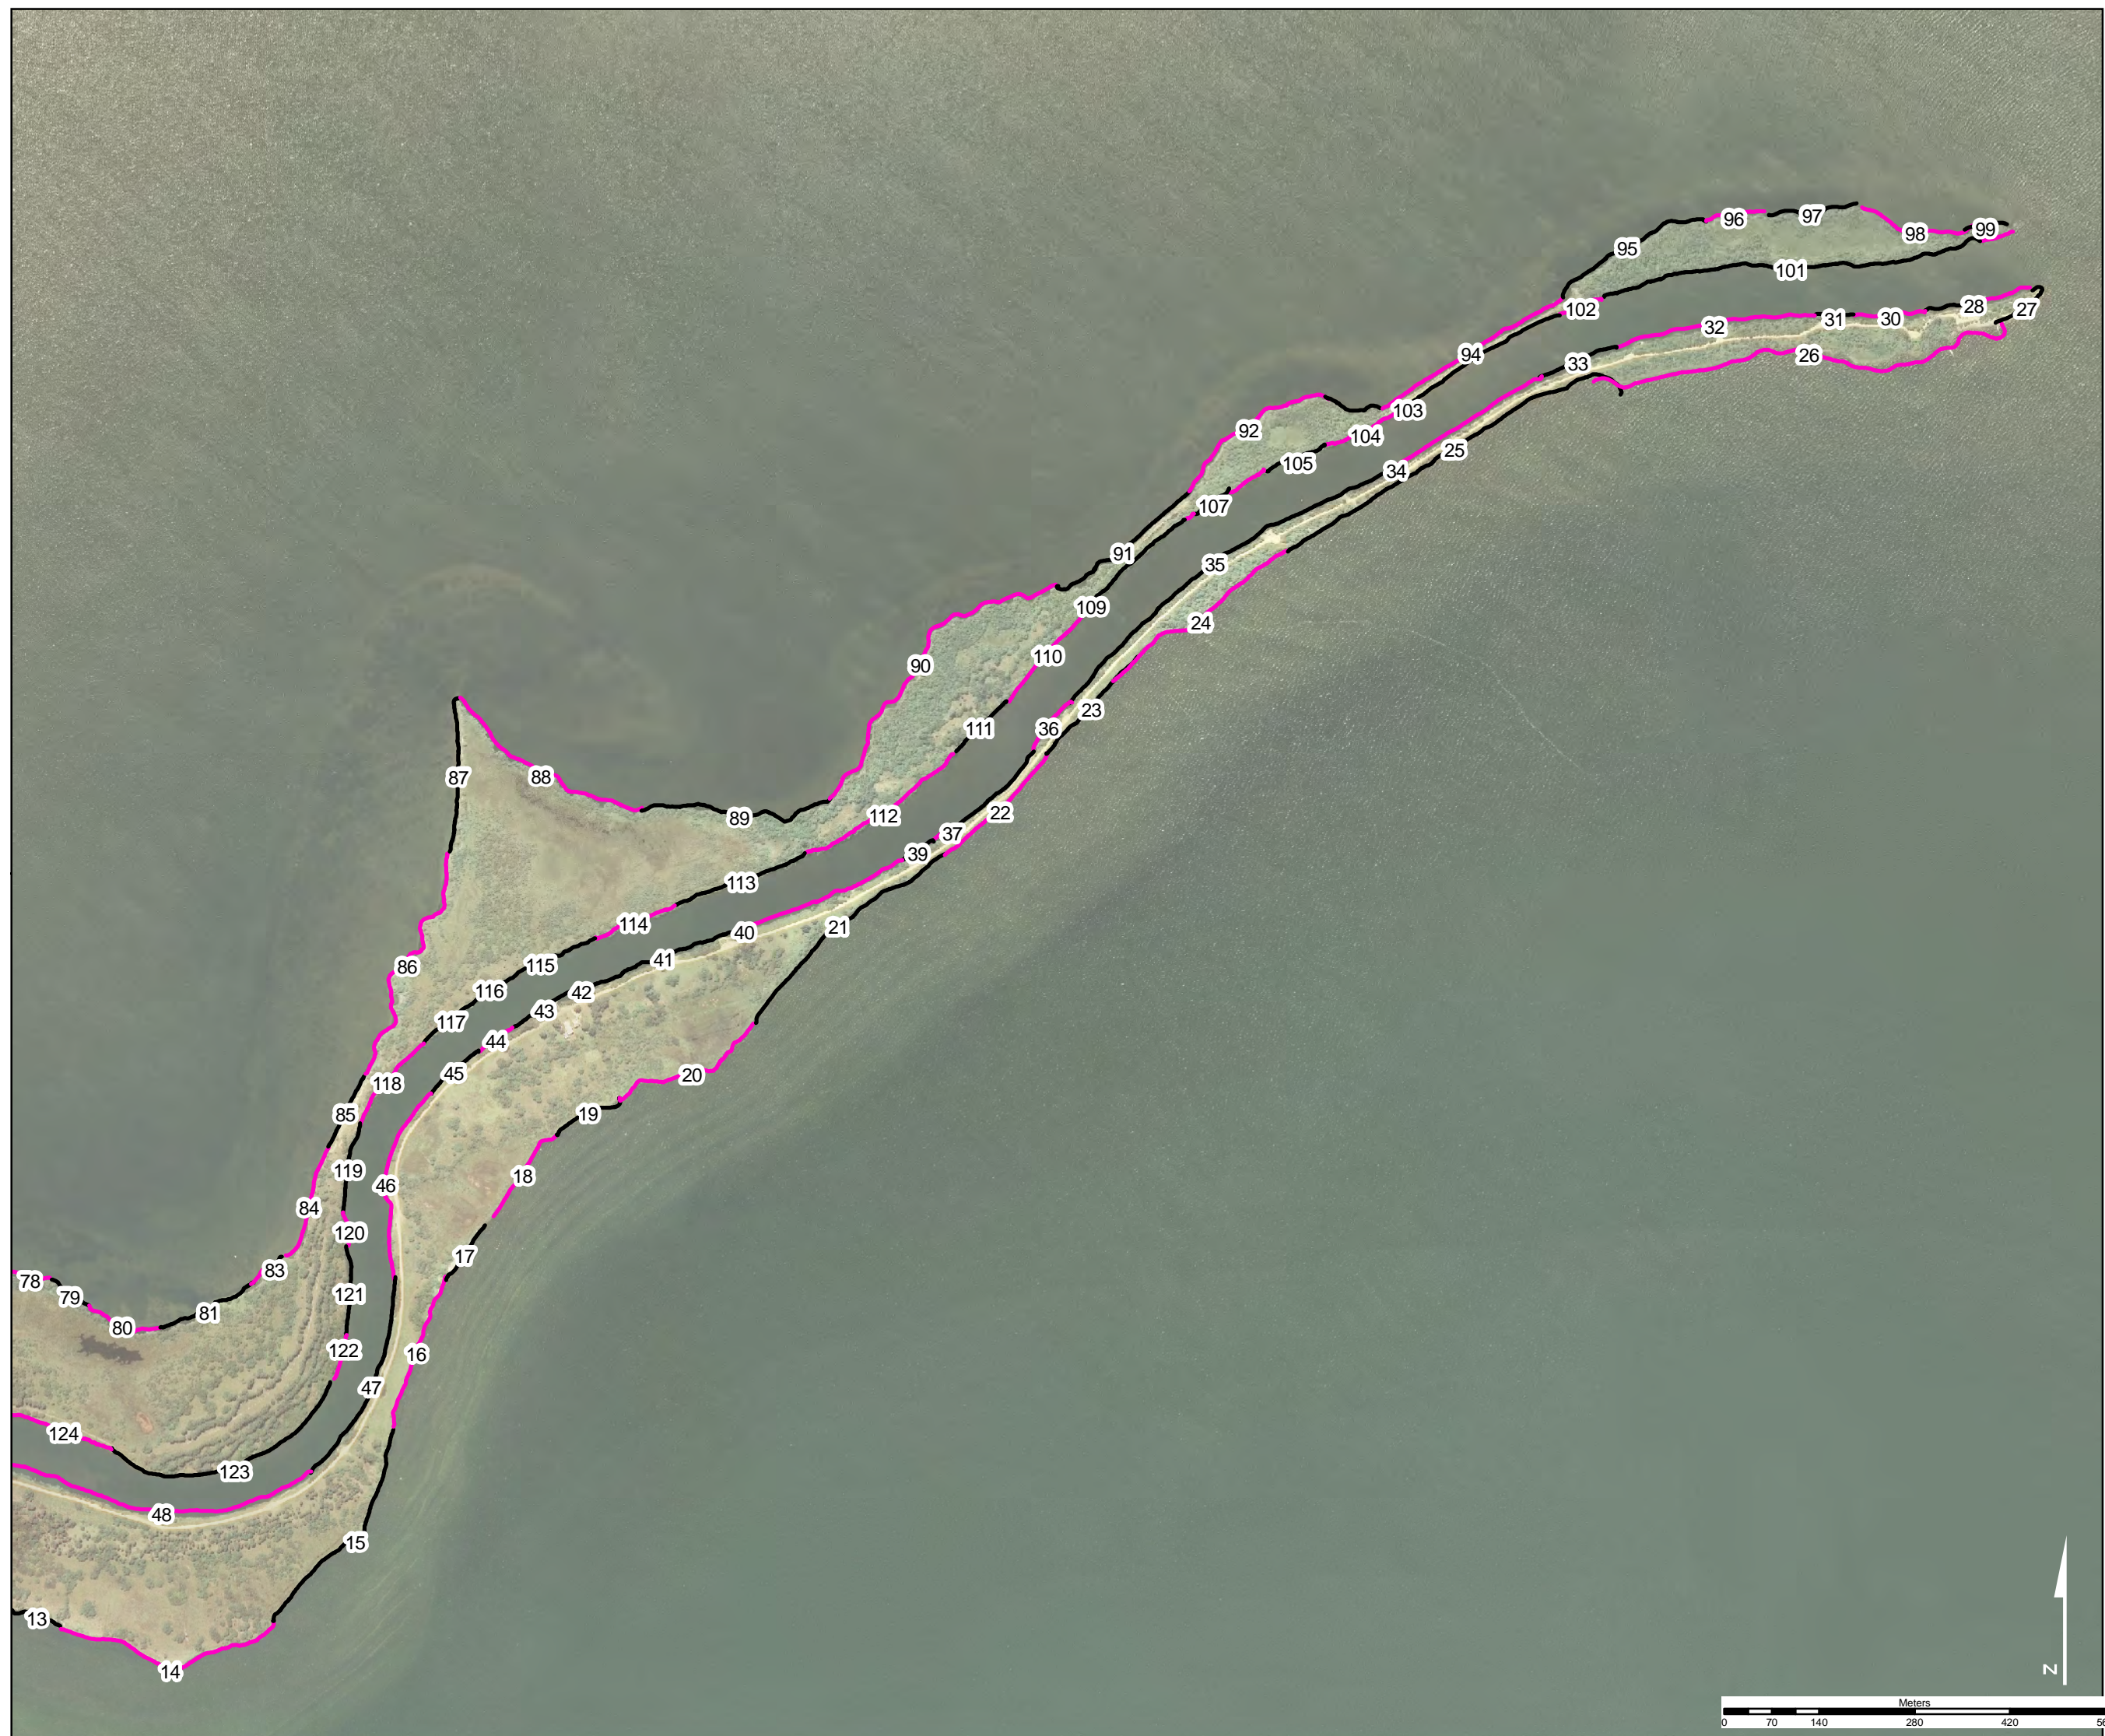
Figure AXX: Shoreline
Sectors (North East)

Shoreline Sector
